AINA CASE STUDY

Hall Bridge, Chelmer and Blackwater Navigation

Volunteers help to design and refurbish an historic footbridge

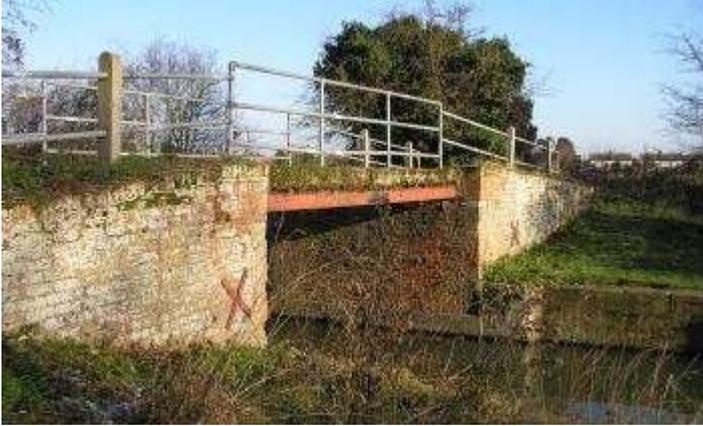
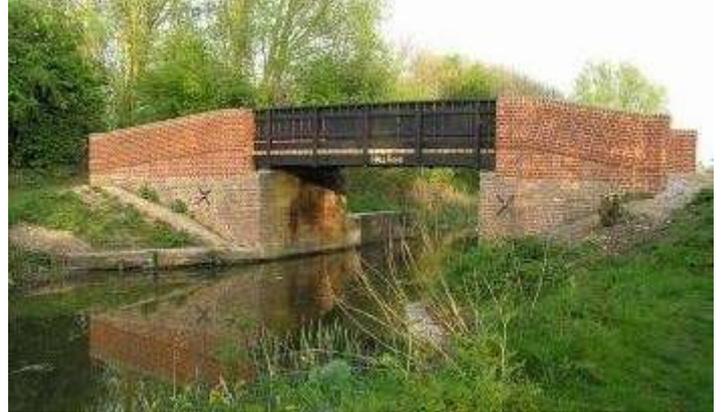
Before and after photos show the marked improvements at Hall Bridge

The design for a replacement bridge was based on the original timber bridges, and all architectural design and engineering work was undertaken by volunteers. Necessary consents were obtained and work commenced in 2010 with a week-long Waterway Recovery Group camp undertaking demolition of the badly eroded old deck. This was followed by local contractors who fitted a new timber bridge deck and rebuilt the brick parapet walls.
